U.S. Department
of Transportation

**DOT HS 807 039
Final Report**

October 1986

Side Door Latch/Hinge Assembly Evaluation

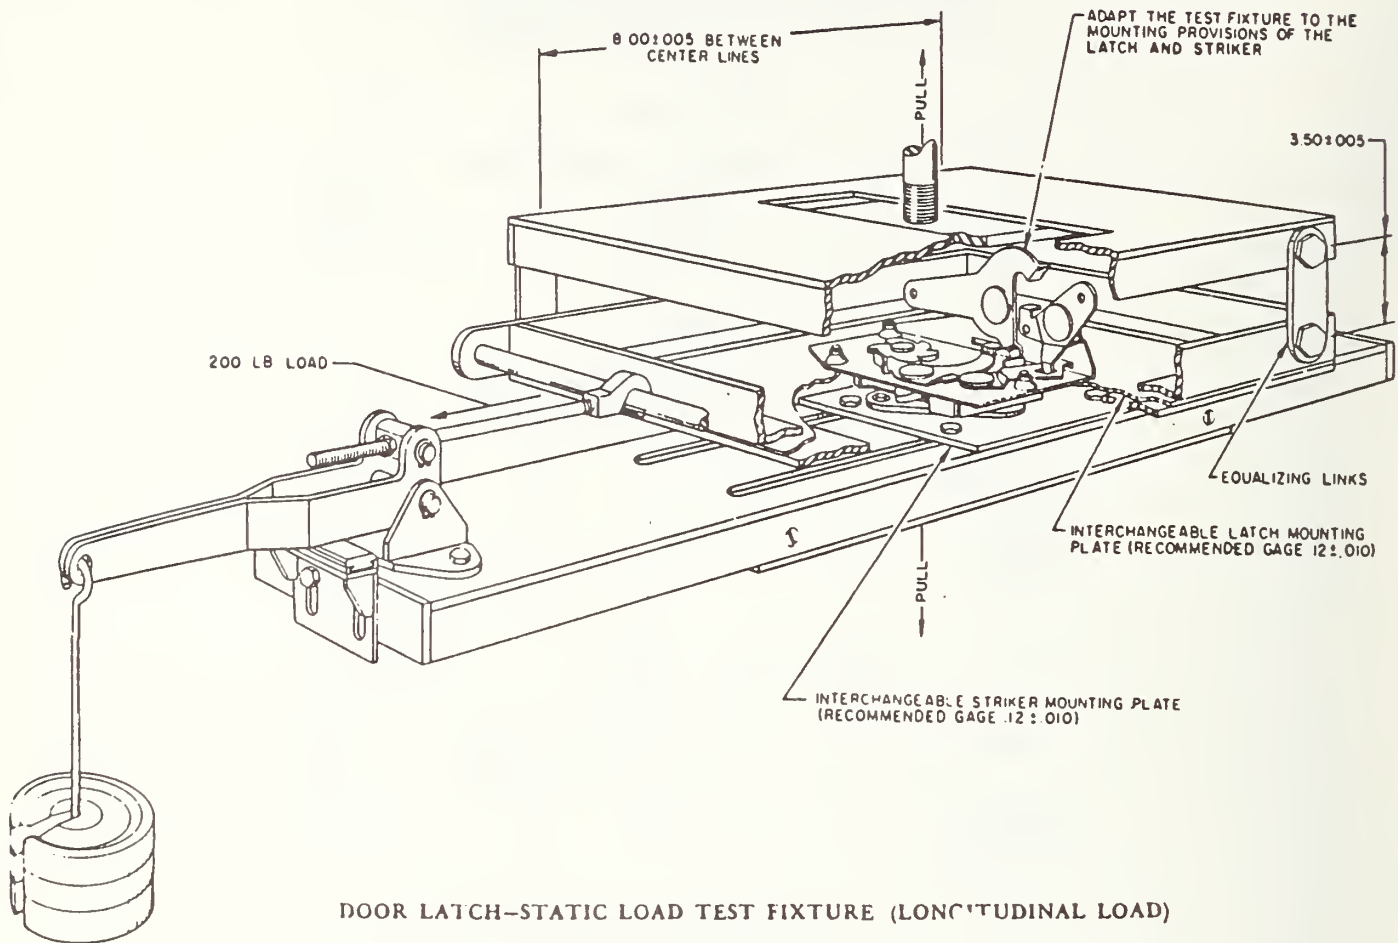
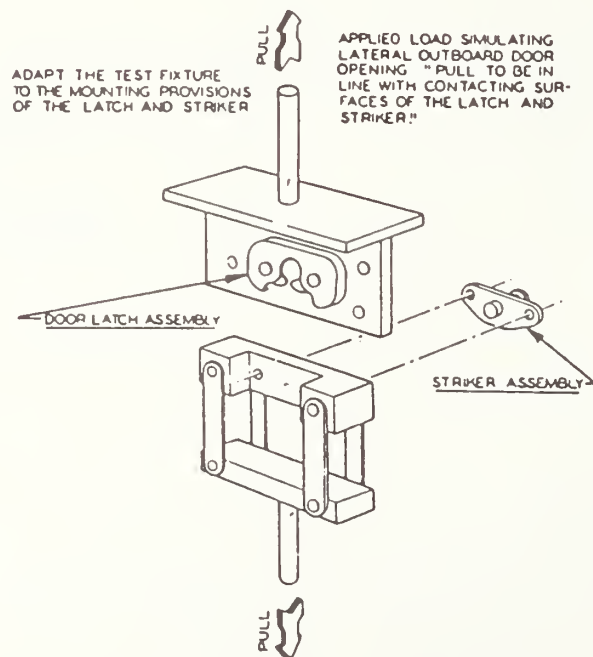
Figure 1 - DOOR LATCH LONGITUDINAL AND TRANSVERSE LOAD DIRECTION

DOOR LATCH-STATIC LOAD TEST FIXTURE (LONGITUDINAL LOAD)

DOOR LATCH-STATIC LOAD FIXTURE (LATERAL LOAD)

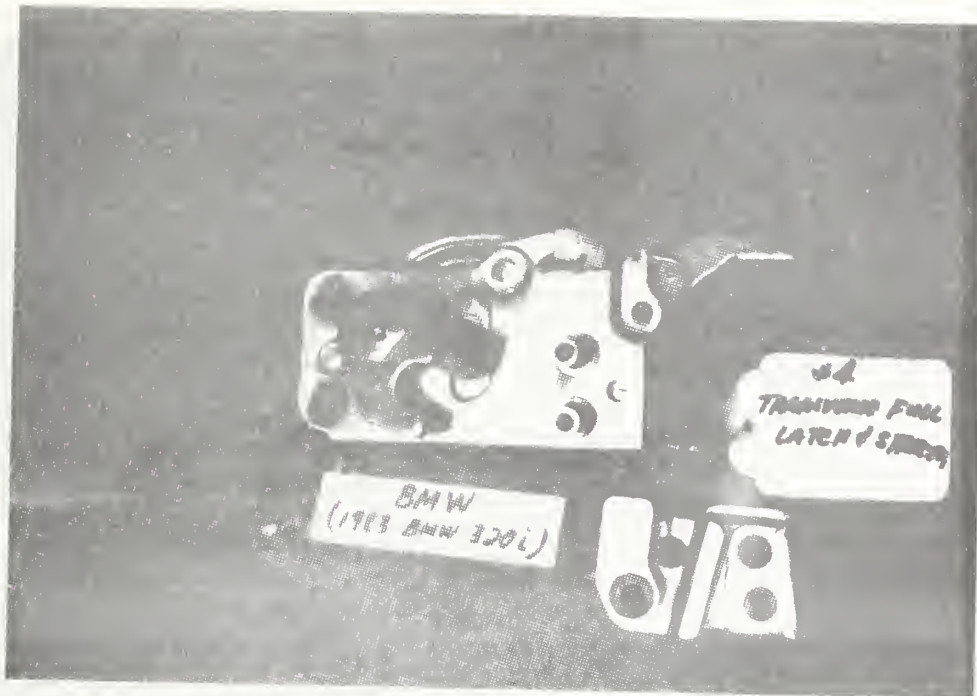
Figure 3. Torn Housing

Figure 3 through 12 show the typical specimens after being tested to failure. Five were tested under longitudinal loading and the other five, under transverse loading. Different modes of failure were

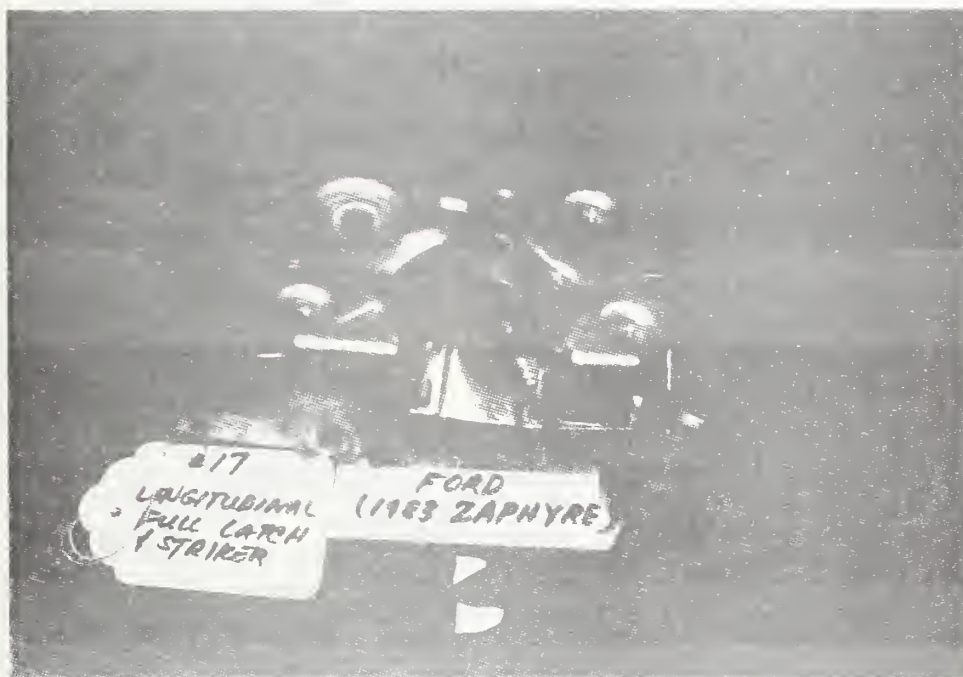
Figure 8, Disengagement of Striker

In general, the latches sustained much lower maximum loads. The average longitudinal and transverse loads of all latches tested were 5,166 lbs (2348 kg) and 3,108 lbs (1431 kg), respectively. The failures were mostly due to the striker disengaging from the capture mechanism due to sheet metal distortion. This type of failure happened under loading in either directions, but most predominately under the transverse loading. In several cases, some other component or housing broke.
